## **Effect of Illumination on Productivity, Safety, and Health of Opencast Mine Operators**

Aditya Prakash<sup>1)</sup> and \*Dr. Hrushikesh Naik<sup>2)</sup>

<sup>1), 2)</sup> *Department of Mining Engineering, National Institute of Technology, Rourkela-769008, India*

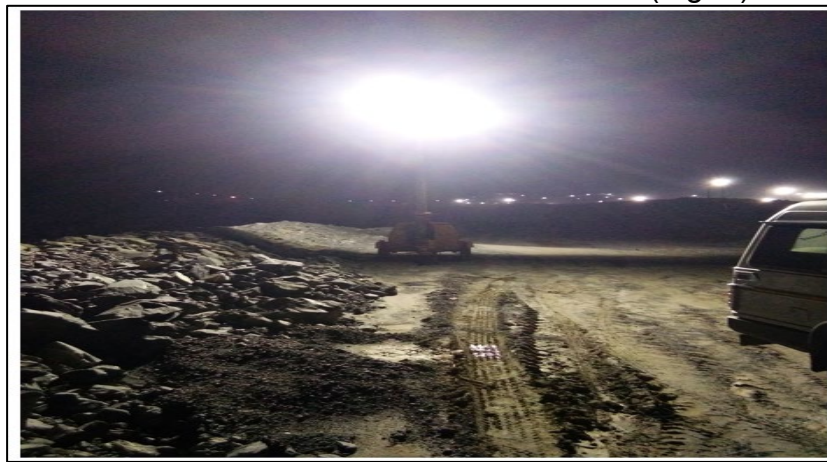
**Fig. 2** Portable DG Tower at Intersection of Haul Roads in Quarry-2, 6 of Mine1

From the safety point of view, the intersection of haul roads is a potential site where collision is likely to occur. In the daytime, natural light allows the operator to easily track the movement of other machinery, but the case is not so at night-time, it is required that sufficient light should be available at every location inside the mine especially the site of potential accident areas. In Mine1, the rate of installation of fixed LED lighting was lagging much behind the rate of face advance. To facilitate the movement of men and machinery in these lagged zones, the portable DG tower was provided at strategically important locations like the intersection of haul roads (Fig. 2). This temporary setup is fulfilling the demand, but it is not safer as it produces glare, which causes eye strain to

dumper operators. An illumination survey was conducted in front of the portable DG tower to check the illumination status at the intersection of haul roads. The illumination survey profile is shown in Fig. 3.

3. Portable DG tower at the intersection of haul roads causes excessive lighting, which affects the operator's productivity and safety.
4. The illuminance level in the operator's cabin was found inadequate as per the standard of illumination.

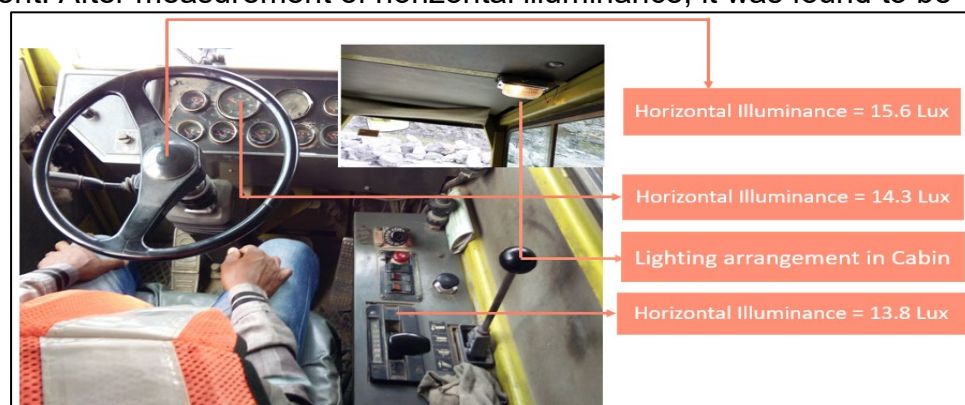
**Fig. 4** Illuminance Level at Frequently used Features of Dumper's Cabin  
**Illumination Survey at Hopper in Mine1**

During field observation, it was found that there was only one light source (yellow light) placed centrally inside the cabin on the top of the roof. The intent is to illuminate all control devices inside the cabin. The reading of horizontal illuminance was taken exactly on top of switches, gear lever, and speed meter. These points are strategically vital for better control of the dumper. The horizontal illuminance at switches, gear lever, and speed meter was 13.8 lux, 13.8 lux, and 14.3 lux respectively. Even though the steering lies in constant control of the operator, then also reading was taken because when the operator changes the gear or presses the switch in that case his one hand goes out of steering, and it is very much required that the operator must put the hand on the position after changing gear or pressing the switch. To do so, the illuminance in the cabin should be sufficient. After measurement of horizontal illuminance, it was found to be 15.6 lux.

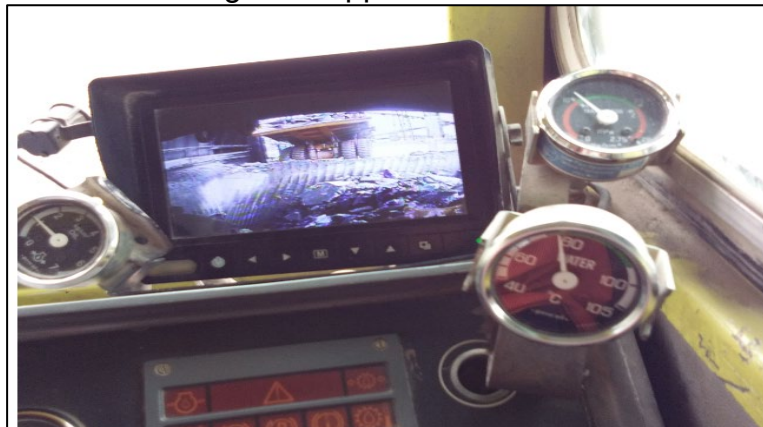
**Fig. 6** Rear Vision Camera Showing View of Hopper Chute

otherwise blur, and the black image will appear in the camera (Fig. 6). Considering above field problems, it is important to assess the light availability at and around the hopper.

5. At the crushing point, the illuminance level was insufficient as inferred from the illuminance survey and image analysis of the rear vision camera.
6. Last edges of the dump yard were devoid of light and variable reflectance causes a variable visual environment.

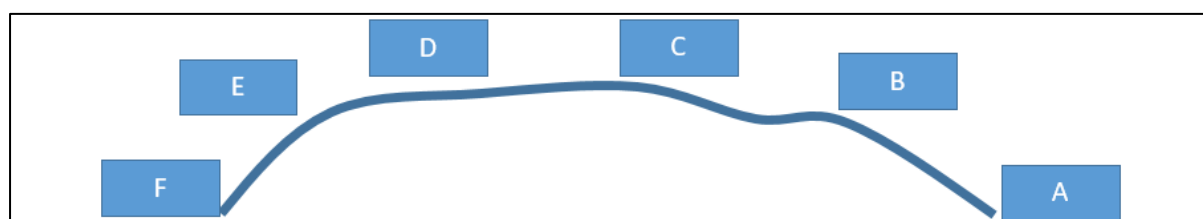
**Fig. 7** Points at the Edge of Dump Yard on which Illuminance Level was Measured

There were many instances of accidents in opencast mines where dumper fall takes place in the dump yard. The reason is manifold but one potential reason is insufficient illumination at the edge of the dump yard. Unless or until the berm at the edge of the dump yard is clearly visible, the dumper operator cannot operate smoothly and there is a high likelihood that he may extend the dumper's body beyond the berm edge. This is the reason behind the fall of dumpers in the dump yard. Thus, ensuring sufficient lighting arrangement at the dump yard to maintain good visibility is vital (Fig. 7).

Points at the edge of The Dump yard of Mine1	Horizontal Illuminance (in Lux)	Vertical Illuminance (in Lux)
A	1.6	2.4
B	1.8	2.3
C	2.1	5.4
D	1.9	4.3
E	0.3	1.7

F	3.2	3.1
---	-----	-----

5. Periodic cleaning of lamps is a must to improve the lighting condition of the dump yard.
6. A portable DG tower is needed to properly illuminate the working face.
7. Permanent or temporary lighting at the entry point of the face is a must.
8. Planning for permanent fixture installation should be done so that the installation would not lag face advancement.
9. Surface treatment can be done but it is a very costly affair.
10. Floodlight can be permanently installed at overhead conveyor point.
11. Water sprinkling over and around crusher point to stop dust to become airborne.

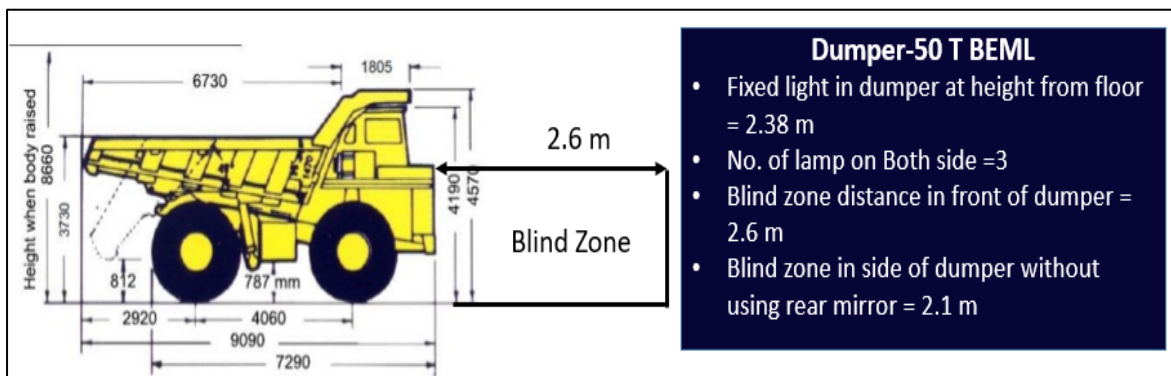
**Fig. 8** Blind Zone in Front and Side of Dumper

The luminaire fixed in dumpers produces some light, which allows it to ply even in absence of external lighting arrangements. To check whether the luminaire setup is adequate for the safe movement of the dumper or not, the illumination survey was carried out by lux meter. No other luminaire was available in the vicinity of light produced by the dumper. Since 2.6m is the blind zone for the dumper thus first reading was taken from about 2.6m from the front edge of the dumper (Fig. 8).

7. The maximum horizontal illuminance level in front of the dumper was 5.73 lux. Thus, the dumper's own light was found inadequate for the dumper to safely ply on the haul road.

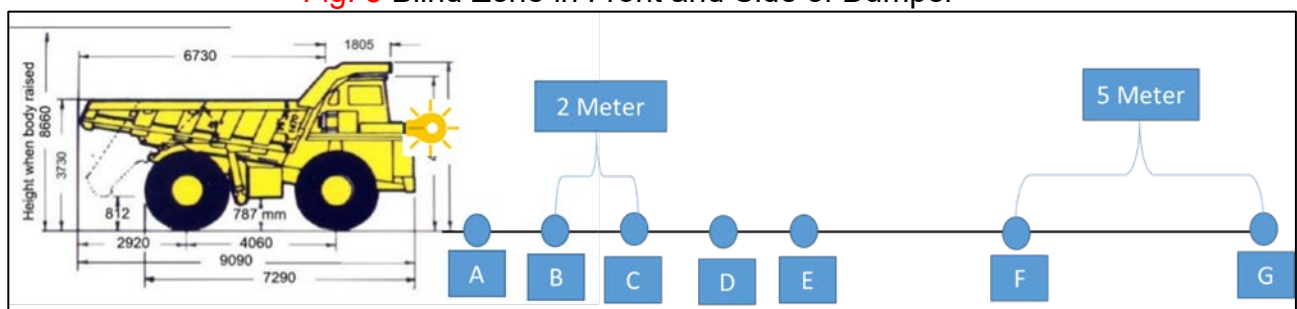
**Fig. 9** Points in Front of BEML Dumper on which Illuminance Level was Measured without any other Luminaire

The first reading was taken at point A, which is about 2.6m from the front edge of the dumper. The next few readings were taken at an interval of 2m up to point E. Interval was increased to 5m up to point G (Fig. 10). When the horizontal illuminance value is reduced to such a level at which visibility of a nearby object is impossible at that point no readings were taken. At point G the horizontal illuminance was 1.48 lux (Table 3), this level of illuminance was not sufficient to recognize smaller objects, and even human identification was difficult.

Points in Front of Dumper in Mine-1	Horizontal Illuminance in Lux	Vertical Illuminance in Lux
A	5.73	15.78
B	5.8	17.6
C	5.4	16.3

D	5.1	15.2
E	4.79	13.9
F	3.29	6.7
G	1.48	3.11

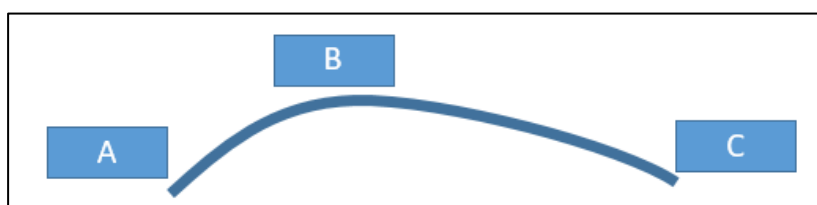
**Fig. 11** Profile of Illumination Survey at Loading Face with Different Points within reach of Excavator Bucket

the material handling on the face is risky because of the limited illumination capacity of the excavator. It cannot illuminate beyond a particular height and any boulders beyond this height are difficult to handle and may fall suddenly and can cause heavy loss to mine authority. The need for a proper illumination survey and design cannot be neglected due to the reasons stated above.

Points at the edge of the face in Mine-1	Horizontal Illuminance (in Lux)	Vertical Illuminance (in Lux)
A	0.72	0.85
B	0.76	0.81
C	0.65	0.68

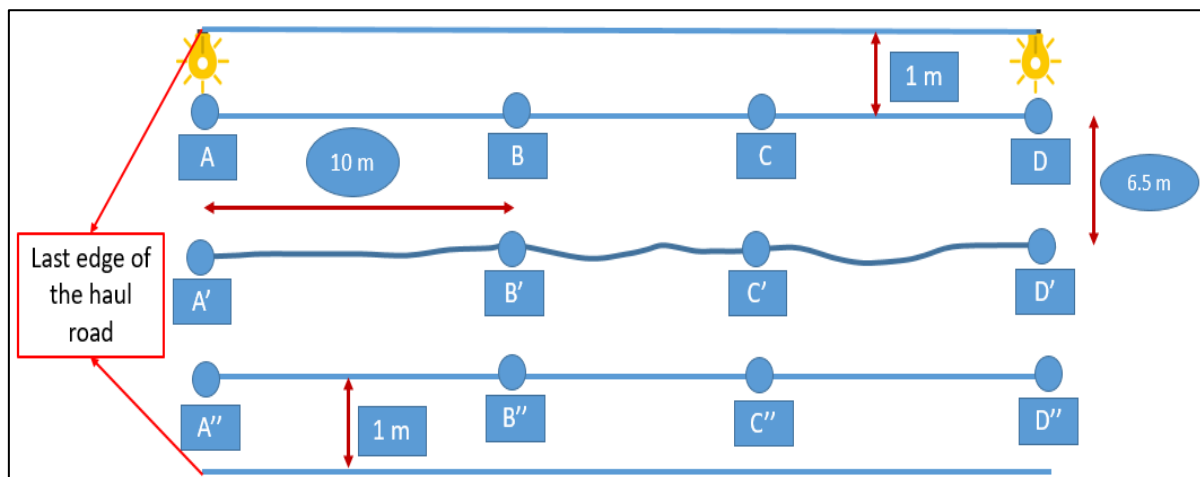
Figure 12: Illumination Survey Profile of Haul Road of Mine2

The illumination survey profile for the haul roads of Mine2 is given in Fig. 12. The spacing between two poles of the height of 8m was 30m. LED type lamp of wattage 120W was in use to illuminate the haul road. The width of the haul road was 15m. Illuminance level readings were taken at 10m due to a paucity of time and resources. As shown in Fig. 12, the first reading was taken at about 1m from pole-1 at point A, the second one on A' lying at the middle of haul road, the last one was taken at A'' which was about 1m from other edges of the haul road. Similarly, all the readings were taken at points shown in Fig. 12. The horizontal illuminance level at different points is given in Table 8.

Sl. No.	Different points on haul roads of Mine-2	Horizontal Illuminance (In Lux)
1.	A	26.3
2.	B	0.2
3.	C	1.7

4.	D	46.4
5.	A'	24.5
6.	B'	1.3
7.	C'	2.4
8.	D'	30.6
9.	A''	14.5
10.	B''	1.5
11.	C''	8.6
12.	D''	18.7

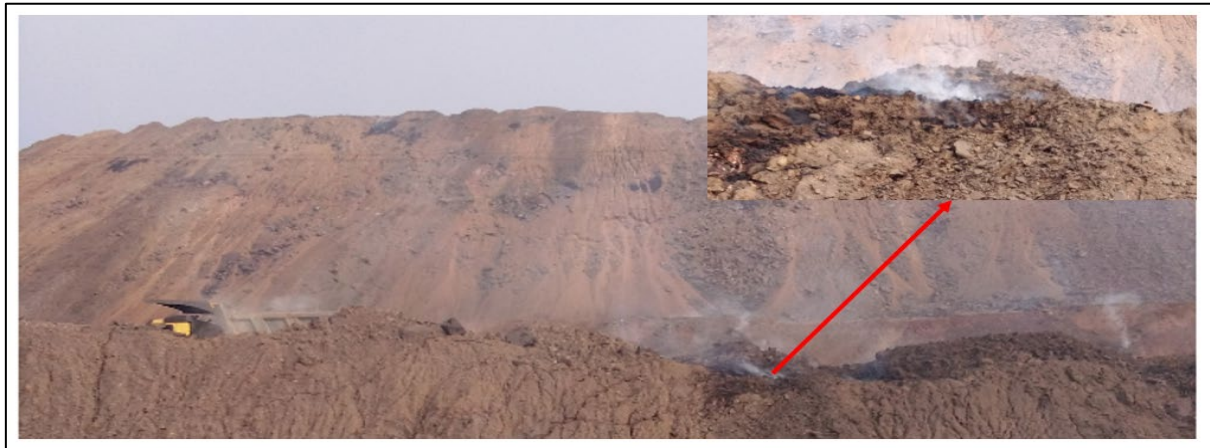
Figure 13: Spontaneous Heating of Coal (Rejects) along Berm Causing Visibility Problem on Haul Road

The reject and some other carbonaceous waste materials were used to act as berm on the edge of the haul road. These carbonaceous materials on exposure to air catch fire due to the auto-oxidation tendency of coaly substance. Smoke and fumes that come out from the berm create visibility issues on the haul road as shown in Fig. 13. The problem became worse when the quantity of carbonaceous material is significantly high because, in this scenario, smoke cloud disperses across the haul road. Therefore, to avoid any accidents and to improve the machine's productivity it is need of the hour to properly segregate coaly substance from the berm so that no spontaneous heating will take place.

1. Illumination plan should go hand in hand with excavation Plan.
2. Dump progress plan should be made, and lighting installation must match the progress plan.
3. Study on the effect of spontaneous heating of coal on visual performance in mine should be done.
4. Replacement of operator's cabin luminaire for a better visual environment in cabin.
5. Portable high mast tower can be commissioned at the loading face to improve workplace illuminance.
6. Portable high mast tower is required at the external dump yard to ensure adequate illumination level.
7. Mix-up of LED and HPSV light must be avoided in maintenance workshop.
8. No additional HPSV lamp is required at OB face as illuminance level is adequate for better visual environment.

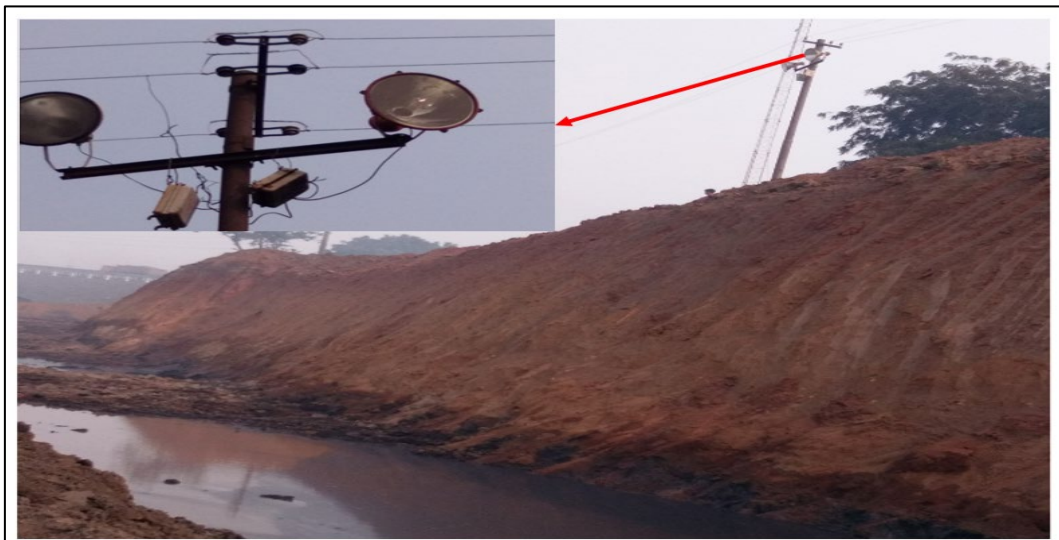
Figure 14: Mine Water Accumulation at Overburden Face with HPSV Lighting Arrangement

The overburden face in Mine2 was having a water seepage problem due to which a considerable amount of water was used to accumulate at the face as shown in Fig. 14. Since surface reflectance of water accumulated area is different from the area having no water above that surface. This accumulation causes variation in the surface reflection of mine, which reflects into a non-uniform lighting environment on the face. Furthermore, a watery face forms a conducive environment for muck formation, which is highly detrimental to the productivity of machinery working in that condition.
