Analytical study on the causes of cracks found at the end of hangers in a through type steel arch bridge

Cracks were observed at the ends of hangers of a steel arch bridge in Nagasaki Prefecture. In this study, eigenvalue analysis was conducted to investigate the cause of the cracks, and the vibration modes were identified. Forced displacement analyses were performed by applying a displacement of 20 mm to the node with the maximum displacement in each vibration mode and similar displacements to the vibration mode to all other nodes. The bending and axial stresses at the hanger ends, where the cracks were found, were examined before and after the thickness loss due to corrosion. Additionally, the natural frequency of the hanger was determined and compared with that of the entire bridge vibration mode. This result suggests that the two were not resonant.

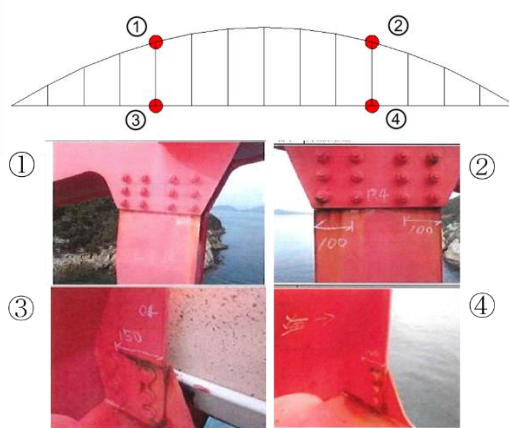
Fig.3 Found cracks

The subject of this study is a through-type steel Langer arch bridge with a span length of 150 m and a width of 8.7 m. Cracks were detected at the ends of the fourth hanger from the bearing, and all occurred near the gusset plates. In addition, section loss due to corrosion was observed. Based on these observations, it was inferred that the

cracks were caused by a combination of bending and axial stresses induced by wind-induced vibrations, along with stress concentration due to corrosion.

The locations and photographs of the cracks are shown in Fig. 3. In general, cracks tend to occur in welded joints. However, the cracks found in this bridge were not located at the welds but rather near the gusset plates at the ends of the hangers. Since section loss due to corrosion was also observed in these areas, it was considered that the cracks were caused by the combined effect of bending and axial stresses induced by wind-induced vibration, along with stress concentration due to corrosion.

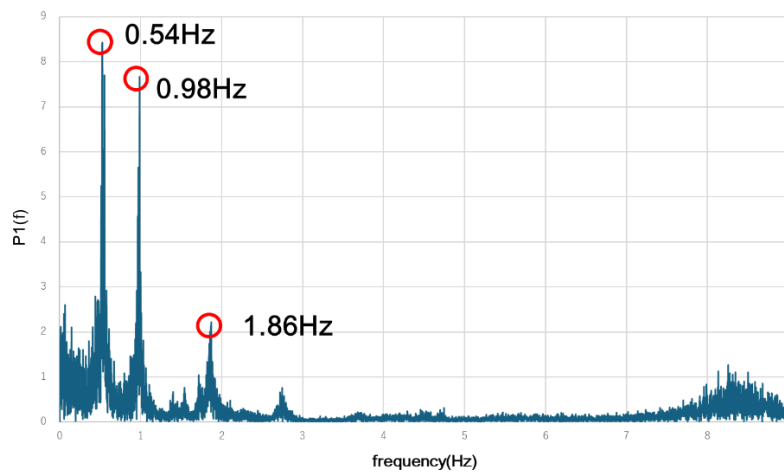
Fig.5 Strain power spectrum

Prior to conducting the forced-displacement analysis, the higher-order vibration modes of the entire bridge were obtained, and the results are listed in Table 3. The power spectrum of the measured strain data is shown in Fig. 5. The strain gauge was positioned at the seaward flange edge on the lower end of the 4th hanger from the bearing where the crack was observed.

Based on these results, it was determined that the bridge primarily vibrated in the 1st, 3rd, and 7th modes, which were used for the forced-displacement analyses.

20 % higher than 53 N/mm², suggesting that if vibrations occurred in this mode, they could have contributed to the crack initiation, whereas the 7th mode cannot be definitively considered the primary cause either since the power of this mode was approximately 1/4 of that of the 1st and 3rd modes, as shown in Fig. 5.

Since there was a possibility that axial stress might be amplified due to resonance, a comparison was made between the natural frequencies of the hanger and those of the entire bridge. As shown in Fig.5 and Table 6, the natural frequencies of the entire bridge and hanger did not exhibit closely matching values. Therefore, it is concluded that resonance does not occur between the vibrations of the entire bridge and those of the hanger.

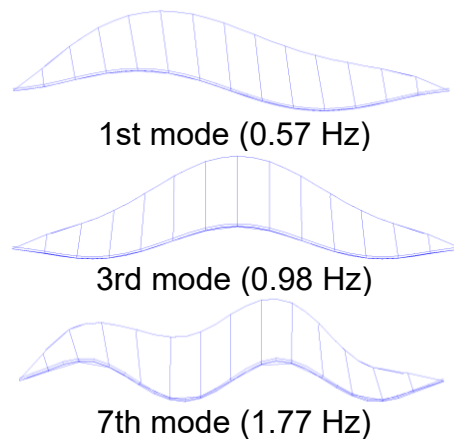
Fig. 6 Vibration mode diagram

The node with the maximum displacement in the entire bridge was identified for each mode based on the mode shape. A vertical displacement of 20 mm, corresponding to the maximum displacement observed during the typhoon, was applied to the node with the maximum displacement, that is at the 1/4 point for the 1st mode, 1/2 point for the 3rd mode, and 1/8 point for the 7th mode. Similar displacements proportional to each vibration mode were applied to all other nodes. Using the results of this analysis, the bending and axial stresses at the end of the cracked hanger were calculated under normal conditions from the bending moment and axial force, as listed in Table 4. The corresponding stresses under section-loss conditions are listed in Table 5.

Since the normal stress ranges in the 1st mode were below 53 N/mm², the vibration in this mode cannot be directly identified as the cause of the crack initiation. However, the normal stress ranges at the cracked hanger end in the 3rd and 7th modes exceeded 53 N/mm². In the 3rd mode, the normal stress range was 63.4 N/mm², approximately
