## **Effect of Illumination on Productivity, Safety, and Health of Opencast Mine Operators**

Aditya Prakash<sup>1)</sup> and \*Dr. Hrushikesh Naik<sup>2)</sup>

<sup>1), 2)</sup> *Department of Mining Engineering, National Institute of Technology, Rourkela-769008, India*

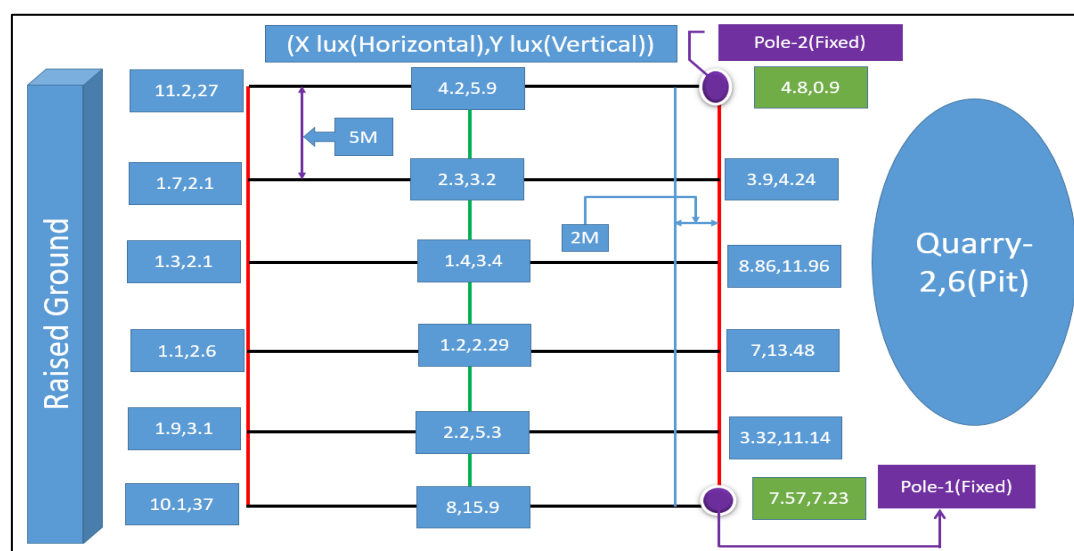
The reading was taken at a 5m interval along the length as shown in the illumination survey profile (Fig. 1). The reading in line with a pole was taken at the end of the berm, which was on an average of 2m from the poles. Readings were also taken on the middle of haul roads and along the opposite edge of haul roads near the raised ground.

**Fig. 1** Grid Pattern Illumination Survey Profile of Haul Road of Quarry-2, 6 in Mine1

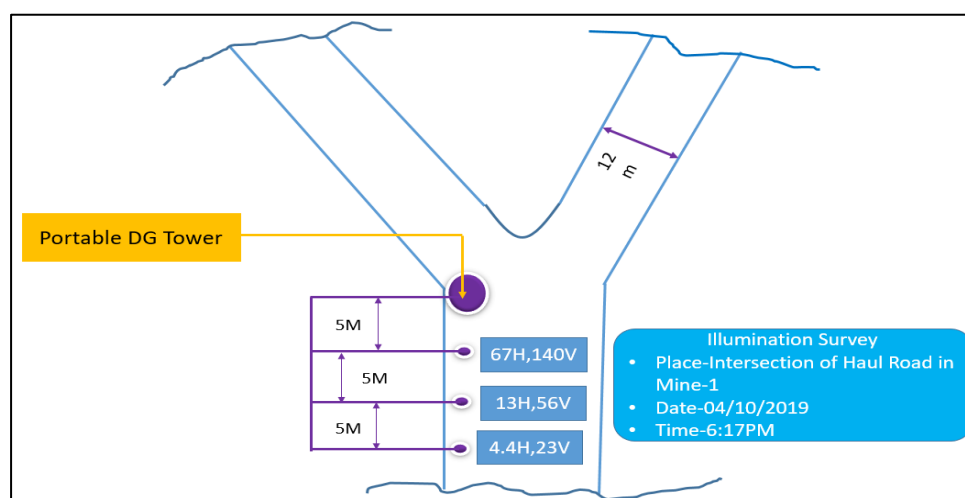
From the safety point of view, the intersection of haul roads is a potential site where collision is likely to occur. In the daytime, natural light allows the operator to easily track the movement of other machinery, but the case is not so at night-time, it is required that sufficient light should be available at every location inside the mine especially the site of potential accident areas. In Mine1, the rate of installation of fixed LED lighting was lagging much behind the rate of face advance. To facilitate the movement of men and machinery in these lagged zones, the portable DG tower was provided at strategically important locations like the intersection of haul roads (Fig. 2). This temporary setup is fulfilling the demand, but it is not safer as it produces glare, which causes eye strain to

dumper operators. An illumination survey was conducted in front of the portable DG tower to check the illumination status at the intersection of haul roads. The illumination survey profile is shown in Fig. 3.

**Fig. 3** Illumination Survey Profile at Intersection of Haul Roads in Quarry-2 & 6  
**Field Conditions and Manner of Illuminance Survey**

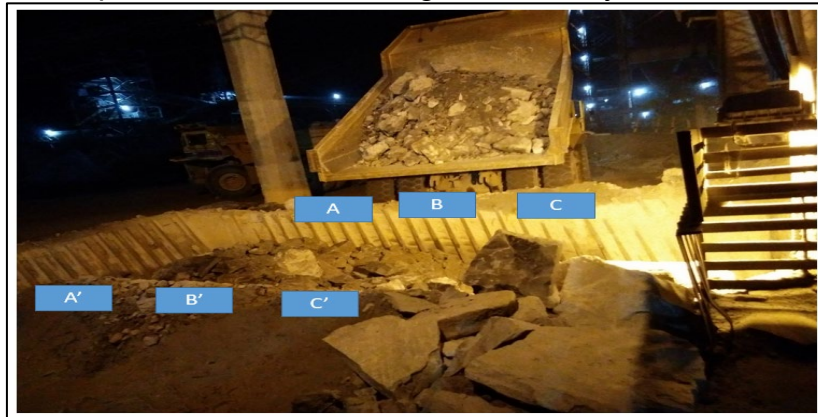
The hopper points in a mine have special significance in the sense that it is a point where the unloading of minerals took place. At night-time, this area around the hopper must be illuminated properly to allow the dumpers to unload the dala material without collision with the last edge of the hopper. The visual field behind the dala determine the visibility of the area and thus the area must have sufficient lighting arrangement (Fig. 5). Furthermore, the rear vision camera installed in the operator's cabin can show the rear images only when the reflectance of the backside is sufficiently high

otherwise blur, and the black image will appear in the camera (Fig. 6). Considering above field problems, it is important to assess the light availability at and around the hopper.

**Fig. 5** Different Points at the Edge of Hopper at which Illuminance Level was Measured

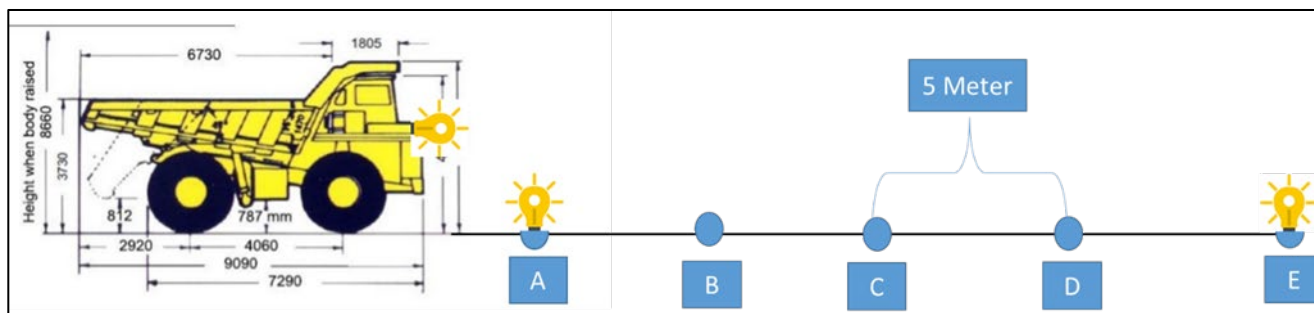
The first reading was taken at point A, which is about 2.6m from the front edge of the dumper. The next few readings were taken at an interval of 2m up to point E. Interval was increased to 5m up to point G (Fig. 10). When the horizontal illuminance value is reduced to such a level at which visibility of a nearby object is impossible at that point no readings were taken. At point G the horizontal illuminance was 1.48 lux (Table 3), this level of illuminance was not sufficient to recognize smaller objects, and even human identification was difficult.

To assess the level of illumination achieved when some other luminaire is available in the vicinity of the dumper's own light, again illumination survey was conducted. In this case, two LED light fixtures were available to illuminate the haul road (Figure 10).

**Fig. 10** Points in Front of BEML Dumper on which Illuminance Level was Measured with Two LED Luminaire Installed along Road Edge
