Analytical study on the causes of cracks found at the end of hangers in a through type steel arch bridge

Cracks were observed at the ends of hangers of a steel arch bridge in Nagasaki Prefecture. In this study, eigenvalue analysis was conducted to investigate the cause of the cracks, and the vibration modes were identified. Forced displacement analyses were performed by applying a displacement of 20 mm to the node with the maximum displacement in each vibration mode and similar displacements to the vibration mode to all other nodes. The bending and axial stresses at the hanger ends, where the cracks were found, were examined before and after the thickness loss due to corrosion. Additionally, the natural frequency of the hanger was determined and compared with that of the entire bridge vibration mode. This result suggests that the two were not resonant.

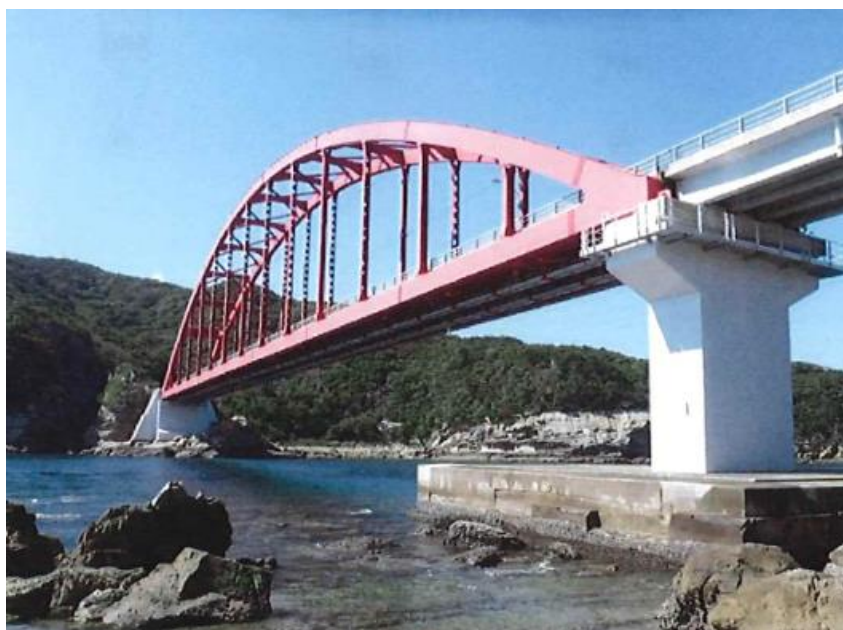
Fig.1 Photograph of the target bridge

The target bridge is a through-type steel Langer arch road bridge with a span length of 150 m and a width of 8.7 m. It was completed in 1986, and 44 years have passed since it started its service. Fig.1 presents a photograph of the target bridge, and Fig.2 shows its general arrangement drawing.

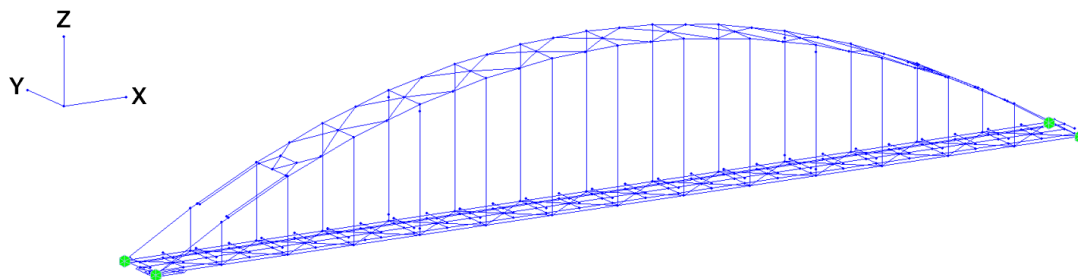
Fig.4 Global model

The commercial software MIDAS Civil was used for analysis. The bridge was modeled using three-dimensional elastic beam elements, as shown in Fig.4. The model consists of 286 nodes and 476 elements. The segments between nodes in this model were not subdivided, and each segment was represented by a single element. The green mark represents a support. The support conditions are described in the following paragraph. The validity of the model was verified by comparing its natural frequencies with those obtained from measured acceleration data.
